# Manhole Inspection Summary

Manhole # S19I1\_034MH

Insp Date: **4/22/08 9:47 AM**

**Location** Address: **3002 huron st**

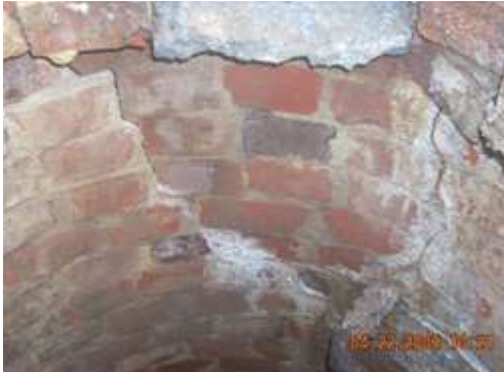
Defect 8

Condition: ☐ Sound ☒ **Cracked** ☐ Root Intrusion ☐ Loose Brick ☐ Deteriorated

crack from chimney to corbel

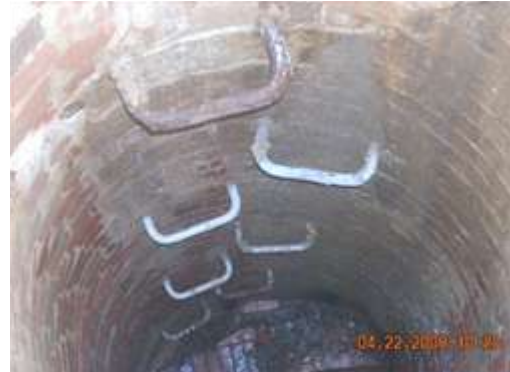
Defect 7

**Steps** Count: **7** Missing: **0** ☒ **Corroded**

corroded top step

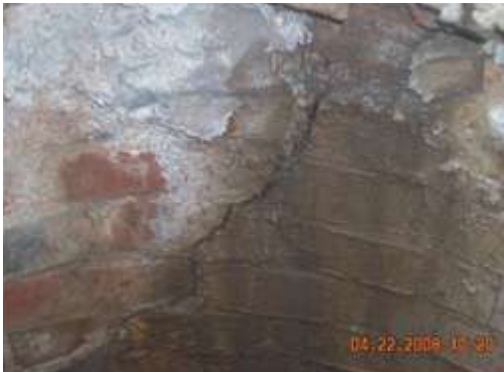
Defect 6

Infiltration: ☐ None ☐ Joint ☒ **Cracks** ☐ Mortar ☐ Roots ☐ Wall

infiltration from corbel crack

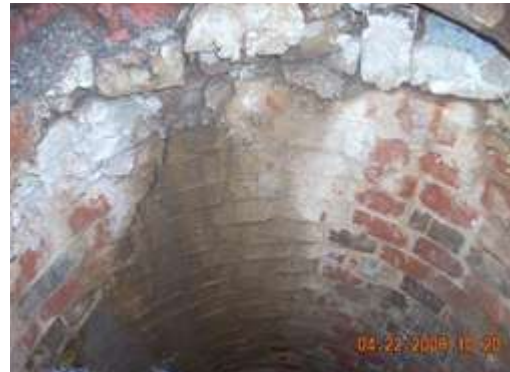
Defect 5

Infiltration: ☐ None ☒ **Joint** ☐ Cracks ☐ Mortar ☐ Roots ☐ Wall

infiltration @ chimney/corbel joint,  
cracked corbel

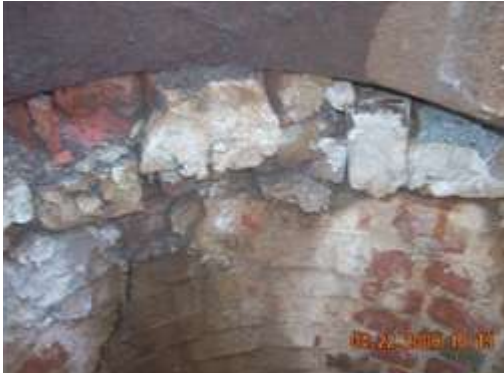
Defect 4

Condition: ☐ Sound ☒ **Cracked** ☐ Root Intrusion ☒ **Loose Brick** ☒ **Deteriorated**

loose chimney bricks

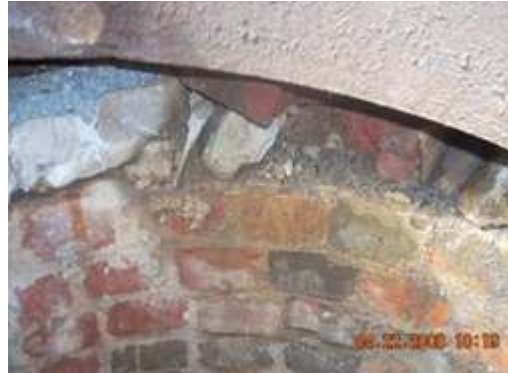
Defect 3

deteriorated chimney

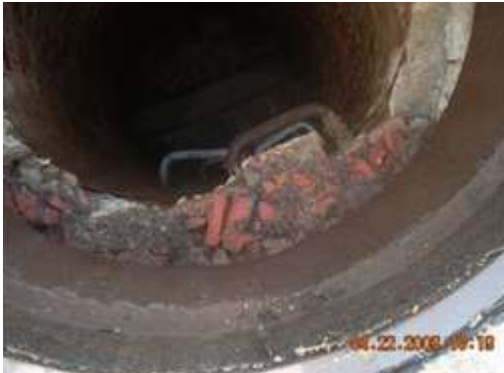
Defect 2

**Frame** Offset: **3** (in.) Condition: ☒ Sound ☐ Cracked ☐ Leaks

frame offset

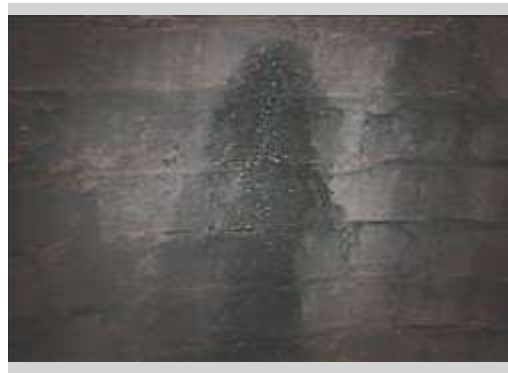
Defect 1

Infiltration: ☐ None ☐ Joint ☐ Cracks ☐ Mortar ☐ Roots ☒ **Wall**

infiltration @ barrel wall

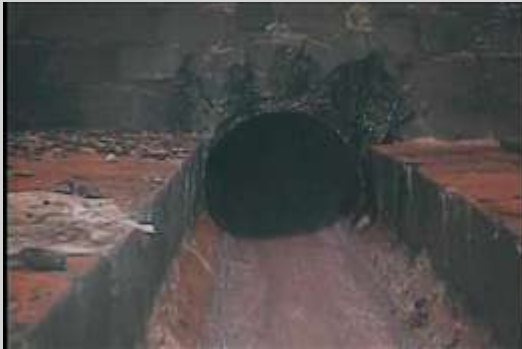
12 O'Clock Outflow

10 in. Circular Gravity Sewer  
Pipe Out @ 12 O'Clock

Pipe Height: **10.8** (in.) Rod and Bar (Angled)  
Pipe Material: **Clay** ☐ Pipe Lined  
Invert Depth: **13.25** (ft.) Flow Characteristics: **Fast**  
Deposits: ☒ None ☐ Mud ☐ Sludge ☐ Debris ☐ Grease  
Silt Depth: **0** (in.) Deposits Extent:  
Infiltration: **Weeper** Pipe Seal Cond: **Cracked**

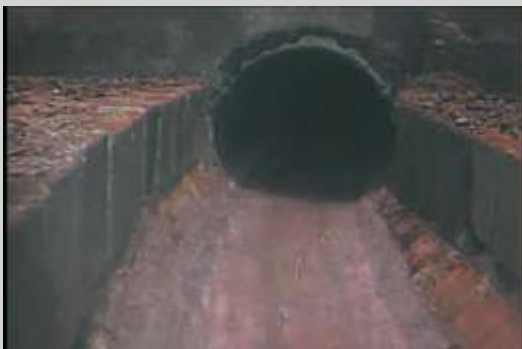
7 O'Clock Inflow

10 in. Circular Gravity Sewer  
Pipe In @ 7 O'Clock

Pipe Height: **10.8** (in.) Rod and Bar (Angled)  
Pipe Material: **Clay** ☐ Pipe Lined  
Invert Depth: **12.98** (ft.) Flow Characteristics: **Fast**  
Deposits: ☒ None ☐ Mud ☐ Sludge ☐ Debris ☐ Grease  
Silt Depth: **0** (in.) Deposits Extent:  
Infiltration: **Evidence** Pipe Seal Cond: **Unknown**
